# 4-Pole Steam Turbine Generator Minor Inspection

Quartzelec conducted a minor inspection of a 11,000kV, 50Hz, 4-pole air-cooled steam turbine generator during a full plant shutdown, with additional scope to replace braided flexi busbar in generator line & neutral cabinet

WASTE TO ENERGY | SOUTH WEST ENGLAND

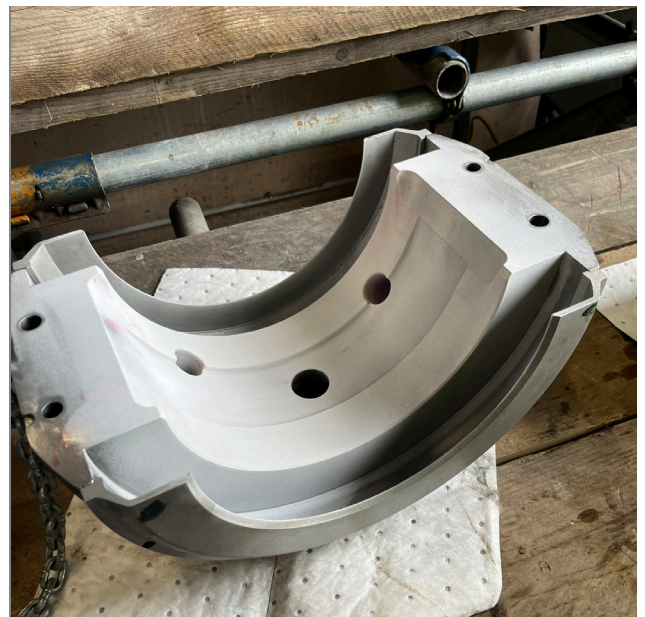
Quartzelec conducted a minor inspection of the generator, including visual and electrical inspections of the rotor, stator, and line and neutral cabinet. Electrical testing revealed that the flexi busbar in the line and neutral cabinet was unfit for purpose, while additional tests confirmed that the exciter and PMG were in good working order. Both the DE and NDE bearings were inspected, with non-destructive testing (NDT) performed on the top half as specified. Bearing clearances were measured before reassembly, and the coolers were visually checked for water leaks. Quartzelec concluded that the rotor, stator, exciter, and PMG were all electrically serviceable. However, the incorrect hardware in the line and neutral side cubicles was identified as a concern. After taking on-site measurements, Quartzelec swiftly sourced and replaced the correct component, ensuring minimal disruption and exceeding customer expectations.
