Pump Motor Overhaul

Quartzelec completes a full overhaul of the 25 meters deep No.7 pump motor at Empingham Pumping Station, restoring it to full operational capacity and ensuring the continued delivery of 600l/s into Rutland Water, guaranteeing a reliable water supply

ANGLIAN WATER | WATER & SEWERAGE | LEICESTERSHIRE, UK

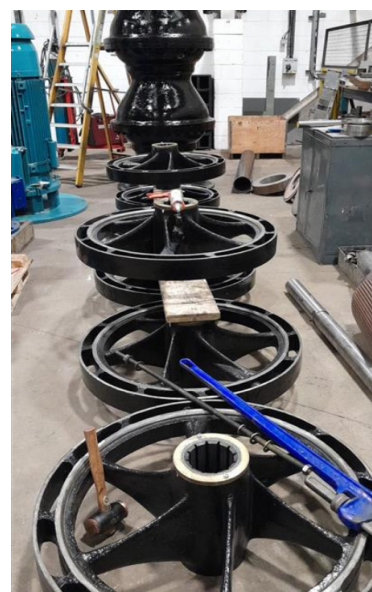
After all measurements were recorded, the rubber bearings were found to be out of tolerance, so new units were manufactured to specification. Nine liners were machined from the pump housings, and new liners were manufactured to restore proper fit and function. The bottom pump sleeve was machined using free-issue spares, and new locking nuts, screw collars, screw rings, and locking rings were manufactured to replace worn fastenings. The impellers were re-tyred and balanced to ensure

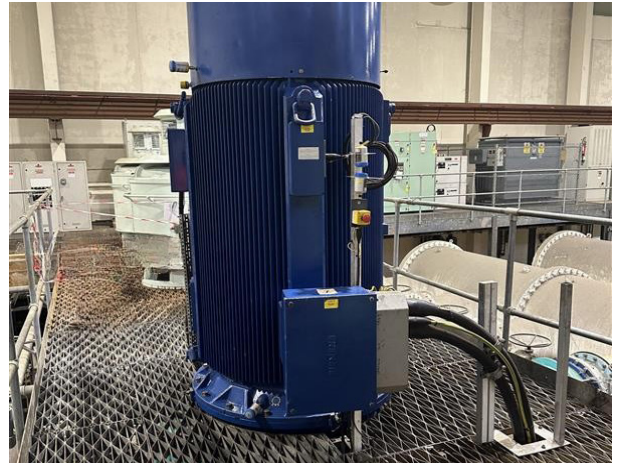
they performed efficiently and smoothly, and the wear rings were skimmed to restore them to their original condition. All threads were dressed to ensure proper fit, and all bolts, nuts, and O-rings were replaced with new components. The parts were shot-blasted and painted to prevent corrosion and further wear, with a primer coating applied for enhanced protection. Both units were reassembled and delivered back to site, ready for operation.

With meticulous attention to detail and a rapid turnaround time, Quartzelec completed the entire overhaul in just 16 weeks, far exceeding the typical 6 months it would usually take for such critical work.
